**VDOT High Polymer Asphalt – Implementation of NCAT Test Track Research**

**Southeastern Asphalt User Producer Group  
Williamsburg, VA**

David P. Shiells, P.E.  
District Materials Engineer

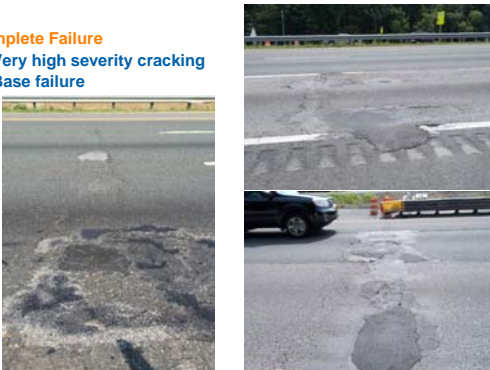
### I-95 Pavement Conditions

**Complete Failure**

- Very high severity cracking
- Base failure

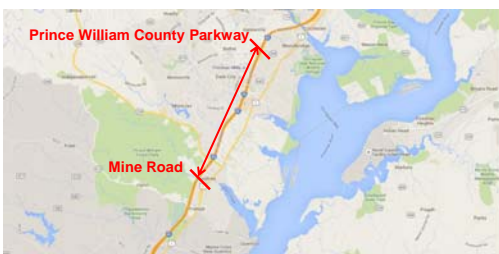
### I-95 in Prince William County

- Prince William County Parkway to Mine Road, SB and NB
- Mill 2"
- Resurface with 2" SM-12.5E

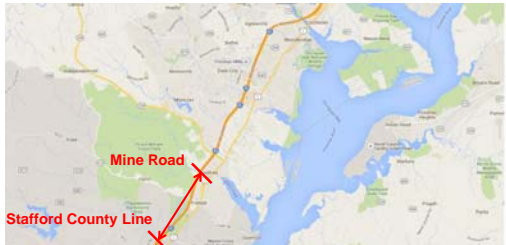
### I-95 in Prince William County

- Mine Road to Stafford County Line, SB and NB
- Mill 2", patch at joints
- Resurface with 2" SM-12.5E (HP)

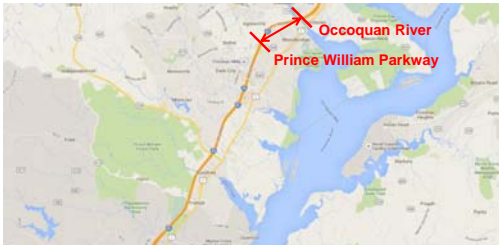
### I-95 in Prince William County

- Occoquan River Bridge to Prince William Parkway, SB
- Mill 2", patch at joints
- Resurface with 1" SM-9.0 (HP) and 1.5" SMA-9.5 (HP)
